# DESIGN OF DOUBLE COMPARTMENT DEVICE FOR MICRO AND MACRO PLASTIC ENTRAPMENT IN FLOWING WATER

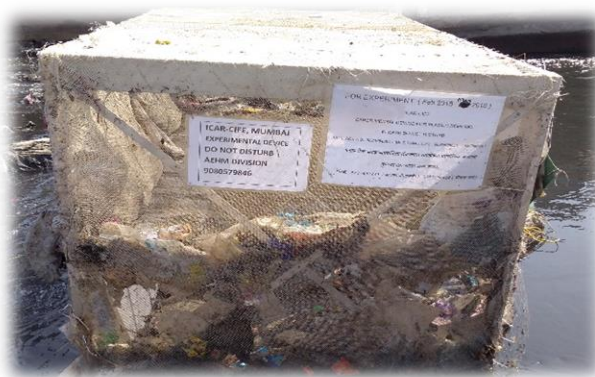
Microplastic, macro- and megaplastic collected in the lower compartment of the device during post-high tide duration. The upper compartment shows the plastic and floating debris collected during high tide

The debris and plastic collection device consist of two chambers made of laminated aluminium. Each chamber is fitted with a movable flap of bakelite at the proximal end and a double layer collection pouch of nylon net at the distal end. The bakelite flap moved inward during the flow of water in the chamber however, a reverse movement is checked by fixing a stopper on the lower arm of the frame. This facilitated the opening of chamber during a unidirectional flow of water during high and low tide conditions. The collection pouch had chambers made of two layers of nylon mesh of 5mm and 0.5 mm, respectively. The inner chamber (5mm pore size) collected the debris and plastic of 5mm and above. However, the outer chamber collected the plastic and debris of 0.5mm or less. The collection pouches are attached to main frame of the chamber and can be removed after they are filled with the debris and plastics. The aluminium device has a mouth opening (260cm×65cm) fitted with two flaps of size (125 X60 cm) to prevent the escape of plastic debris during reverse flow of water. These flaps act like a door during water ingress into the unit. The thickness of bakelite flap is 3mm thickness for smooth movement during tides. The sides of the bakelite flaps are covered with aluminium layer. The main purpose of aluminium device is collection of marine debris and macroplastics (size more than 5 mm) from landward side during low tide and seaward side during high tide.
